VI. OPTION 3: NEW MASONRY VENEER OVER CONC. & ST. WALLS

1.3. Overall Description of the Option 3 Reconstruction Approach

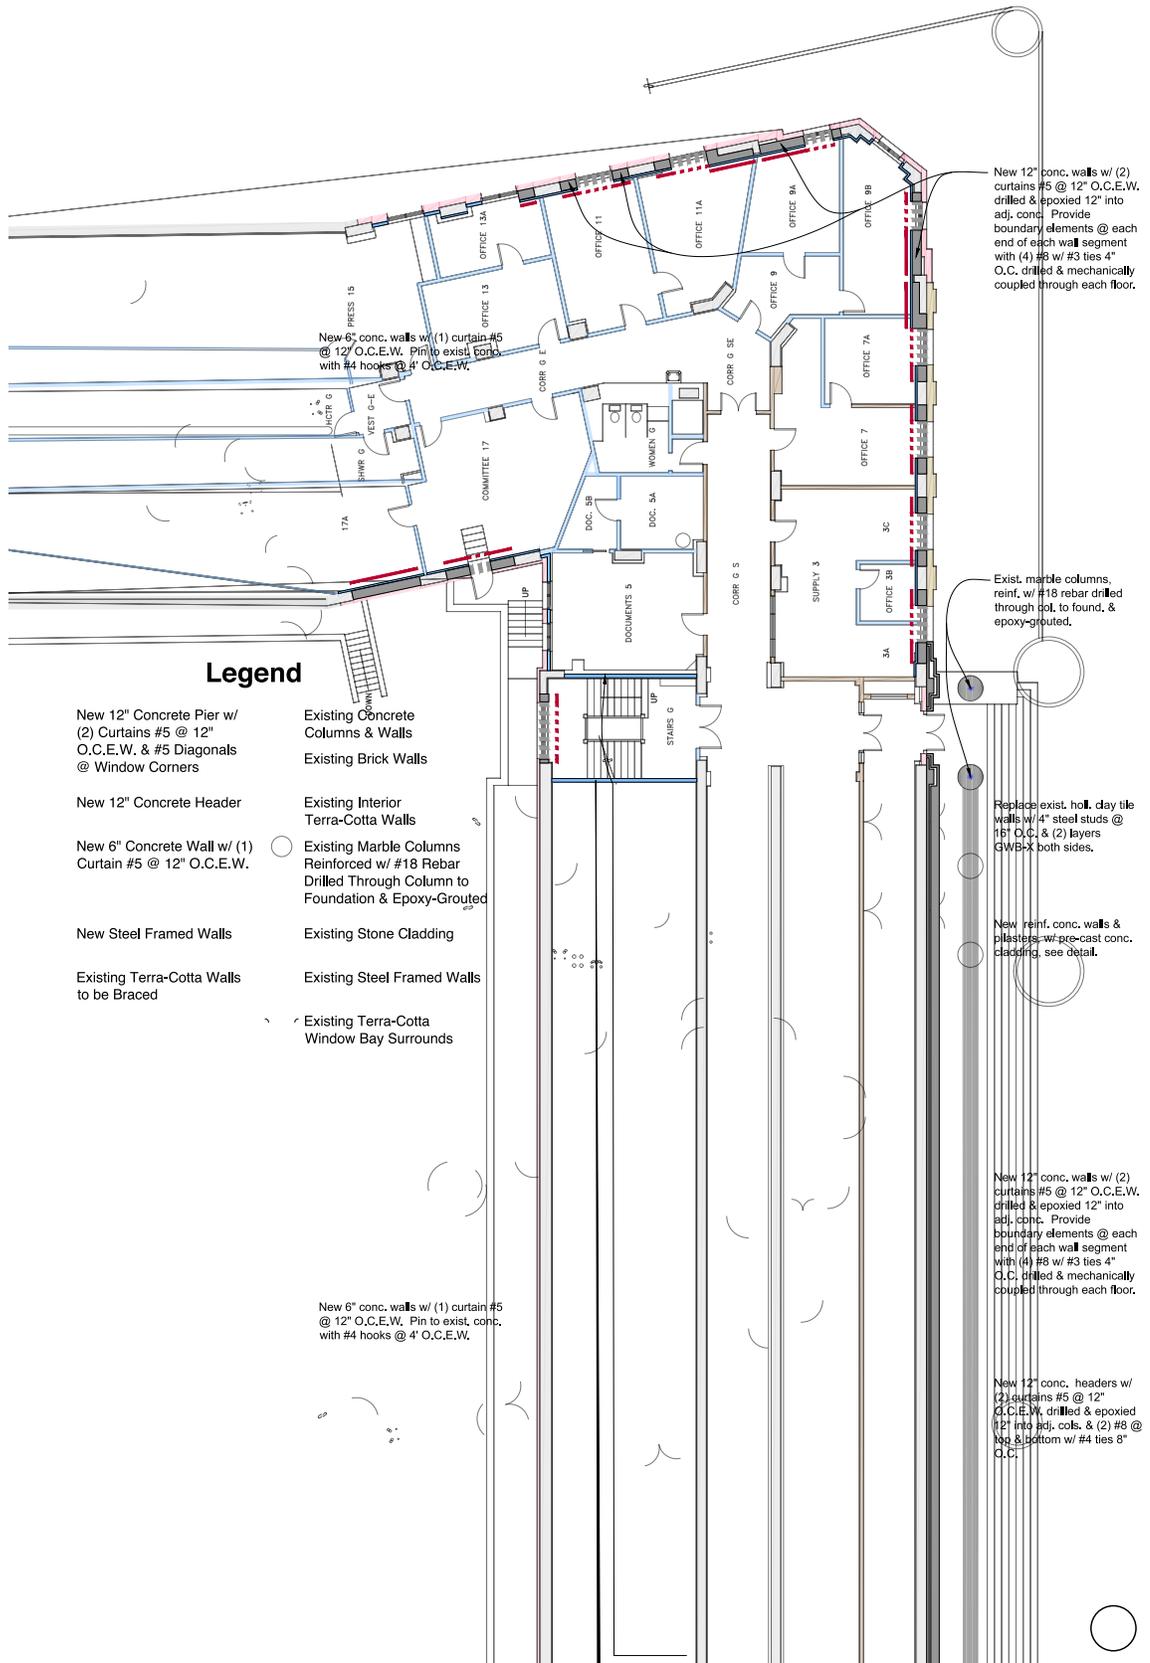
Figure VI-2.1(1): Structural Reinforcing of Building Frame - Ground Floor Level

Somewhat ironically, the elimination of the concrete shear walls in the wall mid-portions reduces the building's overall shear capacity, and thus requires beefier concrete shear walls near the corners extending the full building height, while Option 2 only requires the thicker concrete shear walls from the foundation level up to level 2, and 5" thick walls extend above this. Thus, Option 3 reduces interior floor space near the building corners at all floor levels.

With regard to the building's overall structural frame, recommended corrective work is similar to Option 2, and is not described here in detail. It diverges from Option 2 primarily in that rather than adding concrete back-up walls at all locations, Option 3 adds such concrete walls only where needed to provide lateral load resistance, and places metal-framed back-up walls where concrete shear walls are not needed. Consequently, new concrete shear walls are typically added near all building corners, but mid-portions of the exterior walls only receive the metal-framed walls above and below the windows.

Figures VI-2.1(1-6) show the building's floor plans with specific locations and thicknesses of the new shear walls and piers indicated. See also Figure VI-2.2(1), which shows the related structural work at the foundation level.

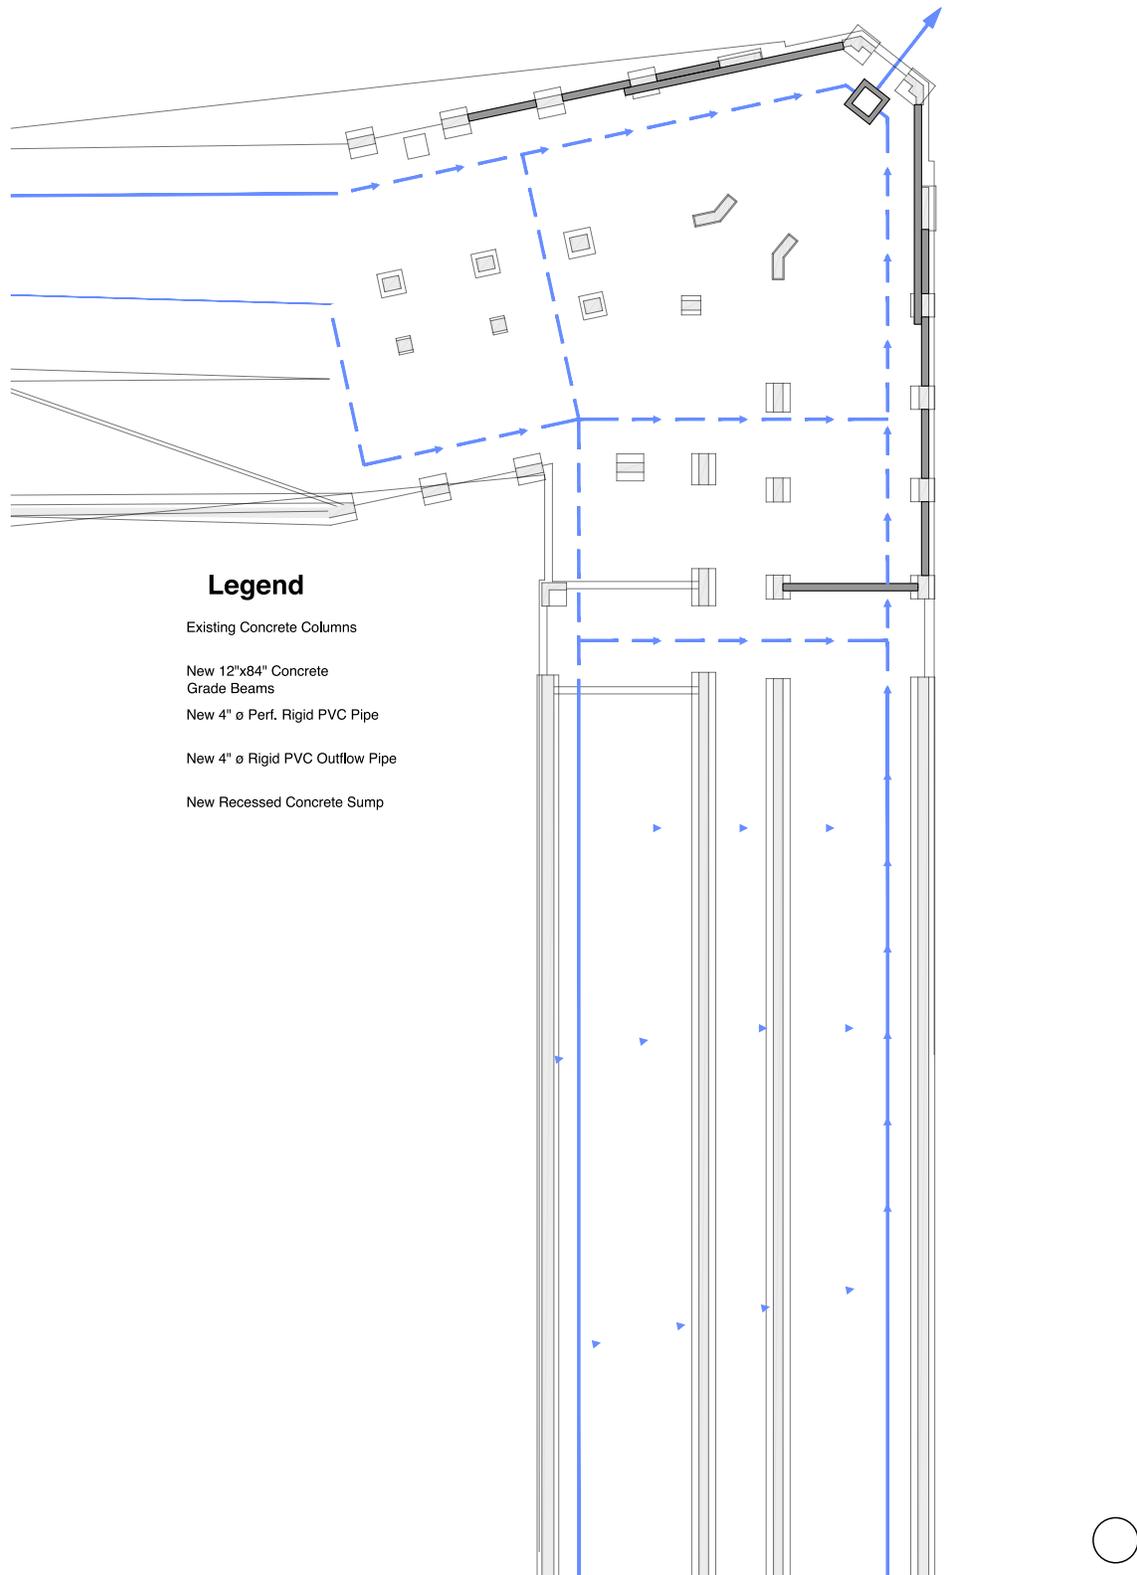
Figure VI-2.2(1): Structural Reinforcing of Foundation System

The Option 3 work related to the addition of new concrete grade beams is very similar to the corresponding work described for Options 1 and 2. However, as this Option 3 approach reduces concrete shear walls at the upper levels, it ironically requires appreciably more extensive concrete grade beams at the foundation level. Consequently, the new grade beams extend along the entire length of the south wall and also extend farther northward along the building's east and west walls than Options 1 and 2.

To limit the destruction of the new grade beams by moisture absorption, as is occurring with the existing foundations, the grade beams should incorporate several measures. First, any reinforcing should be of stainless steel, or hot-dipped galvanized steel as a minimum, to control corrosion. To limit shrinkage cracks and resultant moisture entry, a low shrinkage, low-water concrete mix with polypropylene fiber reinforcing and Kryton KIM admixture should be used.

See Figure VI-2.2(1) for the configuration of these new grade beams.

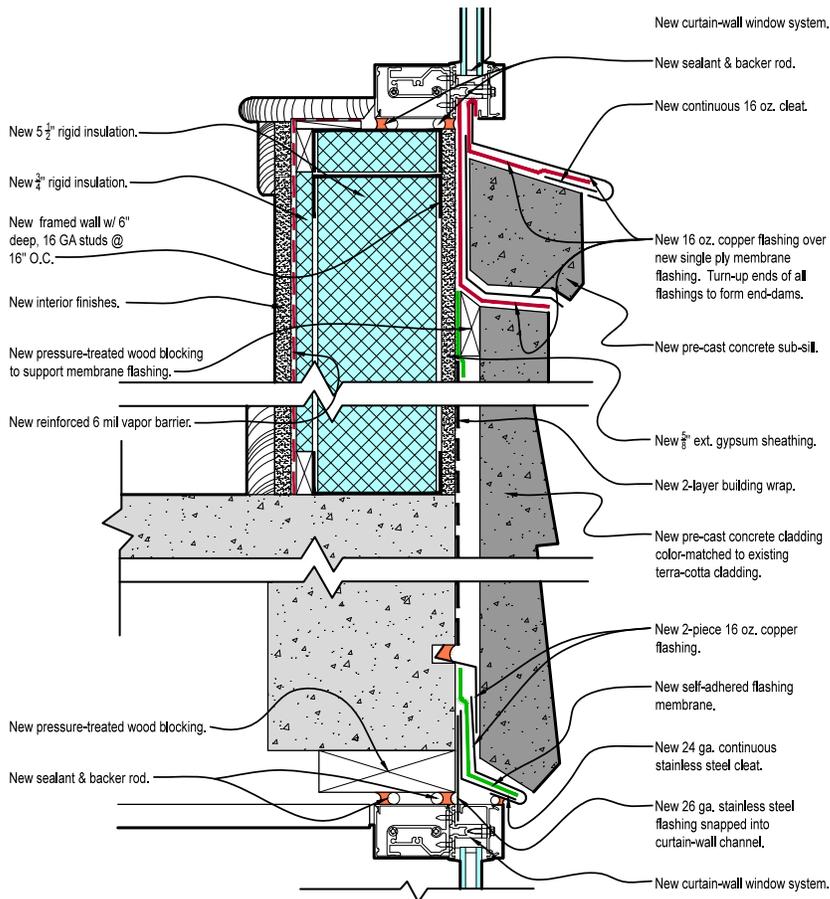
Fig. VI-3.7(1): Replacement of Terra-Cotta Panels With Pre-Cast Concrete Panels

Since the existing terra-cotta wall panels are recessed inward of the abutting brick, the exterior cavity behind the new pre-cast concrete wall panels does not accommodate exterior rigid insulation, and most of the wall insulation is placed within the framing cavities. However, to both limit the shadowing effect, wherein studs become visible through the wallboard over time, and slow rapid heat loss via the metal studs, I recommend that horizontal furring, spaced 16" O. C., be applied over the interior faces of the steel studs to allow at least 3/4" of rigid insulation to be fitted between them. This can be achieved with wood 1 x 3 furring, Z-girts, etc.

To a very large extent, the work is identical to the work of Option 2, as described in subsection V-3.7.2, and is not repeated here in detail. This approach differs from Option 2 in that rather than having concrete back-up walls behind the terra-cotta, these would typically consist of steel stud-framed walls with gypsum sheathing. This approach also replaces the terra-cotta panels with color-matched pre-cast concrete ones.

Figure VI-3.7(1) shows a generic detail for these steel-framed wall portions.

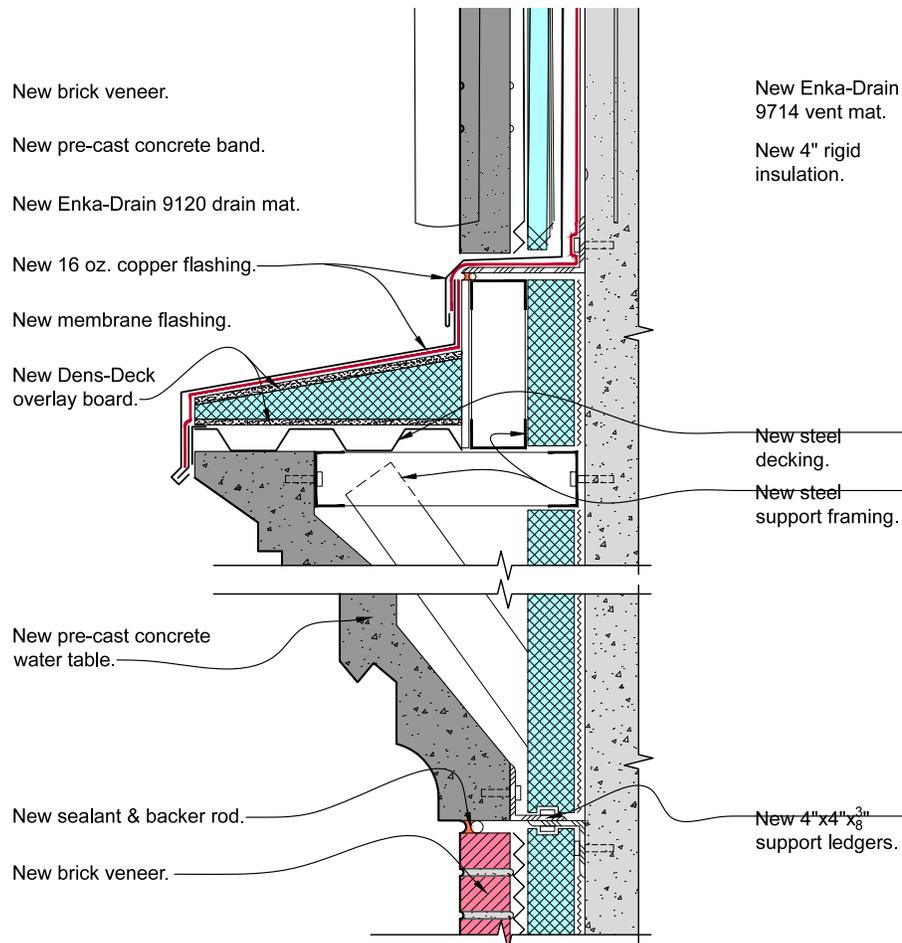
Fig. VI-4.1(1): Water Table Reconstruction

In addition, please note that although the existing water table could be restored and reused in this approach, it would need to be removed to allow other work to proceed, and it would probably be less costly, as well as technically preferable, to replace this water table with a new, pre-cast concrete one, generally similar to the proposed new cornice.

Replacement of this water table with a pre-cast concrete one is recommended. Figure VI-4.1(1) depicts the general scope of this work where the water table occurs by an existing or new concrete column or wall, which represents most conditions on the building. The work would be nearly identical where new steel-framed walls occur, except the specific integration of the through-wall flashing with the back-up wall would be slightly different, and this flashing would lap under the 2-layer building wrap over the exterior gypsum sheathing. Where window sills occur, the flashing cap atop the water table would integrate with the new curtain-wall window system, generally as shown in Figure VI-4.1(2).
